PRELIMINARY INVESTIGATION REPORT

ACCIDENT OF PIA FLIGHT PK8303 AIRBUS A320-214 REG NO AP-BLD CRASHED NEAR KARACHI AIRPORT ON 22-05-2020

PRELIMINARY REPORT

ACCIDENT OF PIA FLIGHT PK8303 AIRBUS A320-214 REG NO AP-BLD NEAR KARACHI AIRPORT ON 22-05-2020

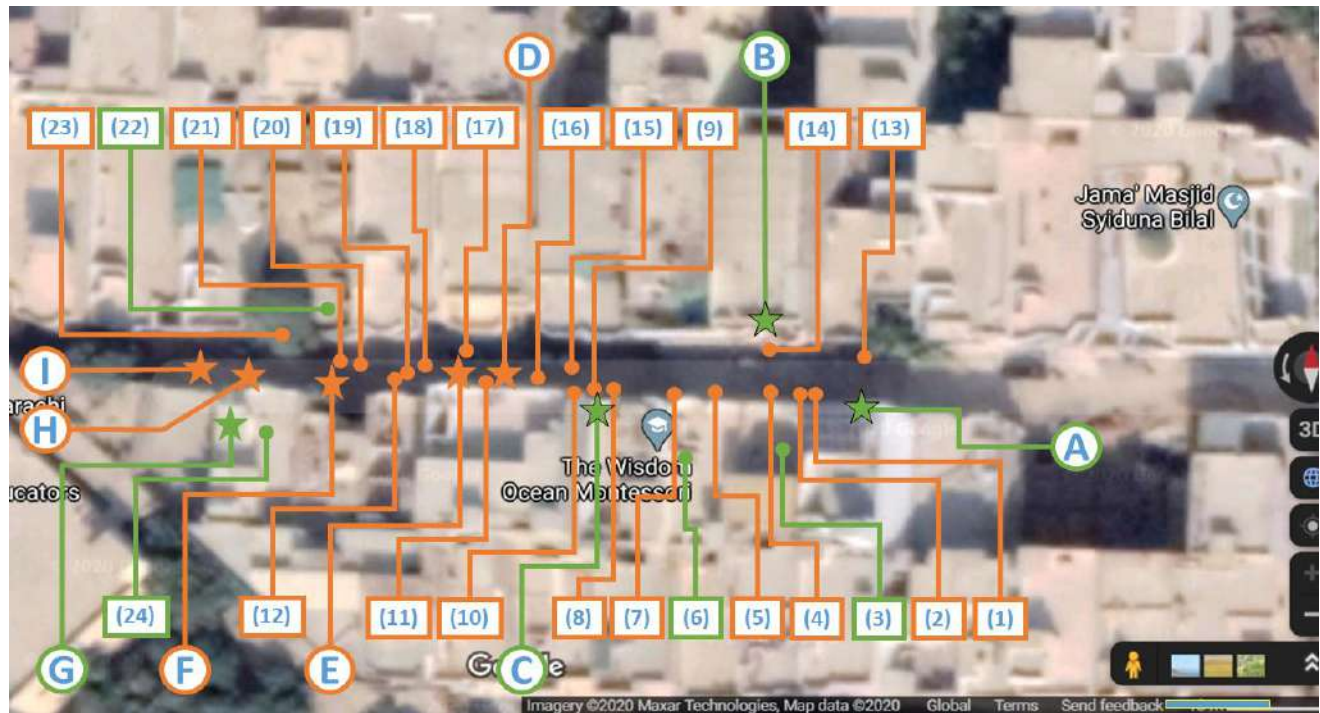
Fig 3 : Wreckage mapping (Google Maps)

12. The layout of the aircraft parts on the accident site is consistent with the aircraft impacting buildings on both sides of the street at low speed. The THSA position before the impact was determined to be 2.8 deg nose up. According to the Rudder Travel Limiting Unit, the aircraft speed before impact was below 150 knots IAS. Several findings indicate an extended landing gear configuration at the time of impact. The free fall mechanism for lowering of landing gears was not used. The slat / flap configuration was determined to be in position slat 1 (ie 18 deg), flaps fully retracted (0 deg). The RAT was seen deployed on CCTV screen shots prior impact.

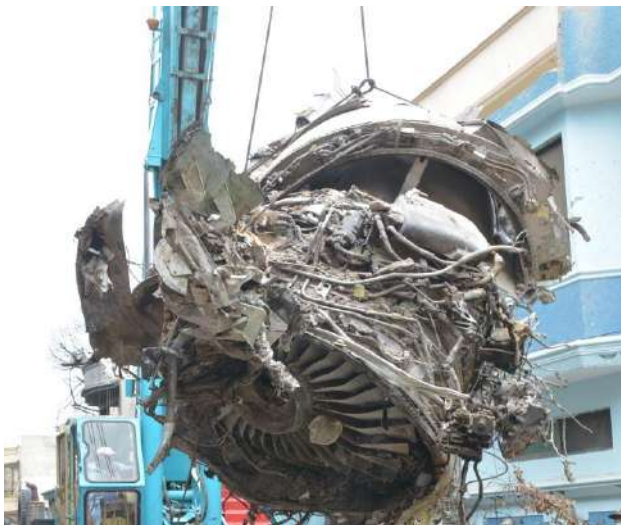
13. Left engine showed evidence of external fire. Visible fan blades condition was consistent with the engine being at low rotational speed at the time of impact, most likely not producing any thrust. Right engine showed evidence of external fire. Fan blades were in good condition being consistent with the engine at low rotational speed at the impact, most likely not producing any thrust at time of impact.

Fig 9 : Left engine being lifted from roof top

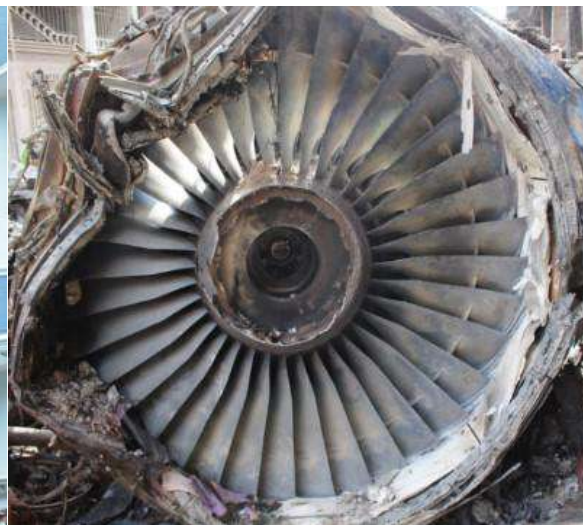
Fig 10 : Right engine

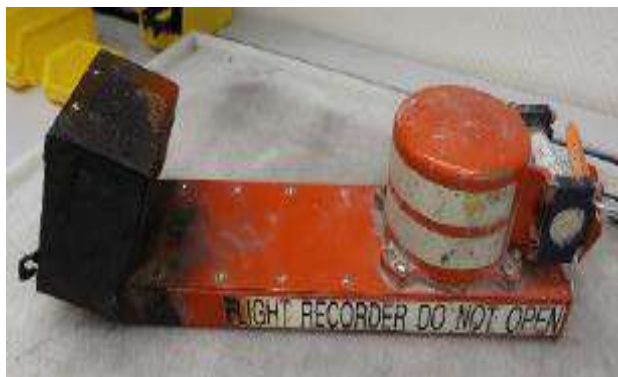
Fig 15 : FDR as recovered from wreckage

19. The CVR recording was found to be of good quality and covered complete flight. However, FDR included the data of the entire flight except after the time when electric power was not available for the FDR. This is as per its designed limitation.

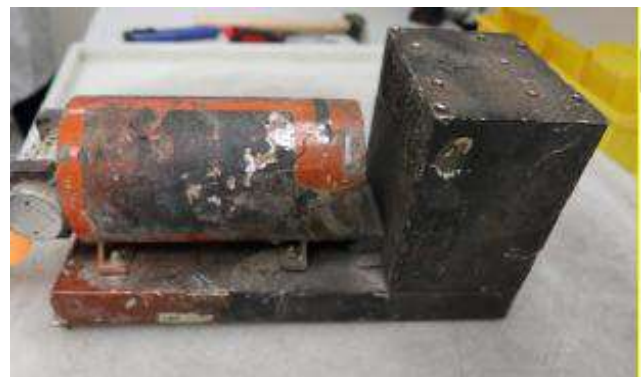
Fig 16 : CVR as recovered from wreckage

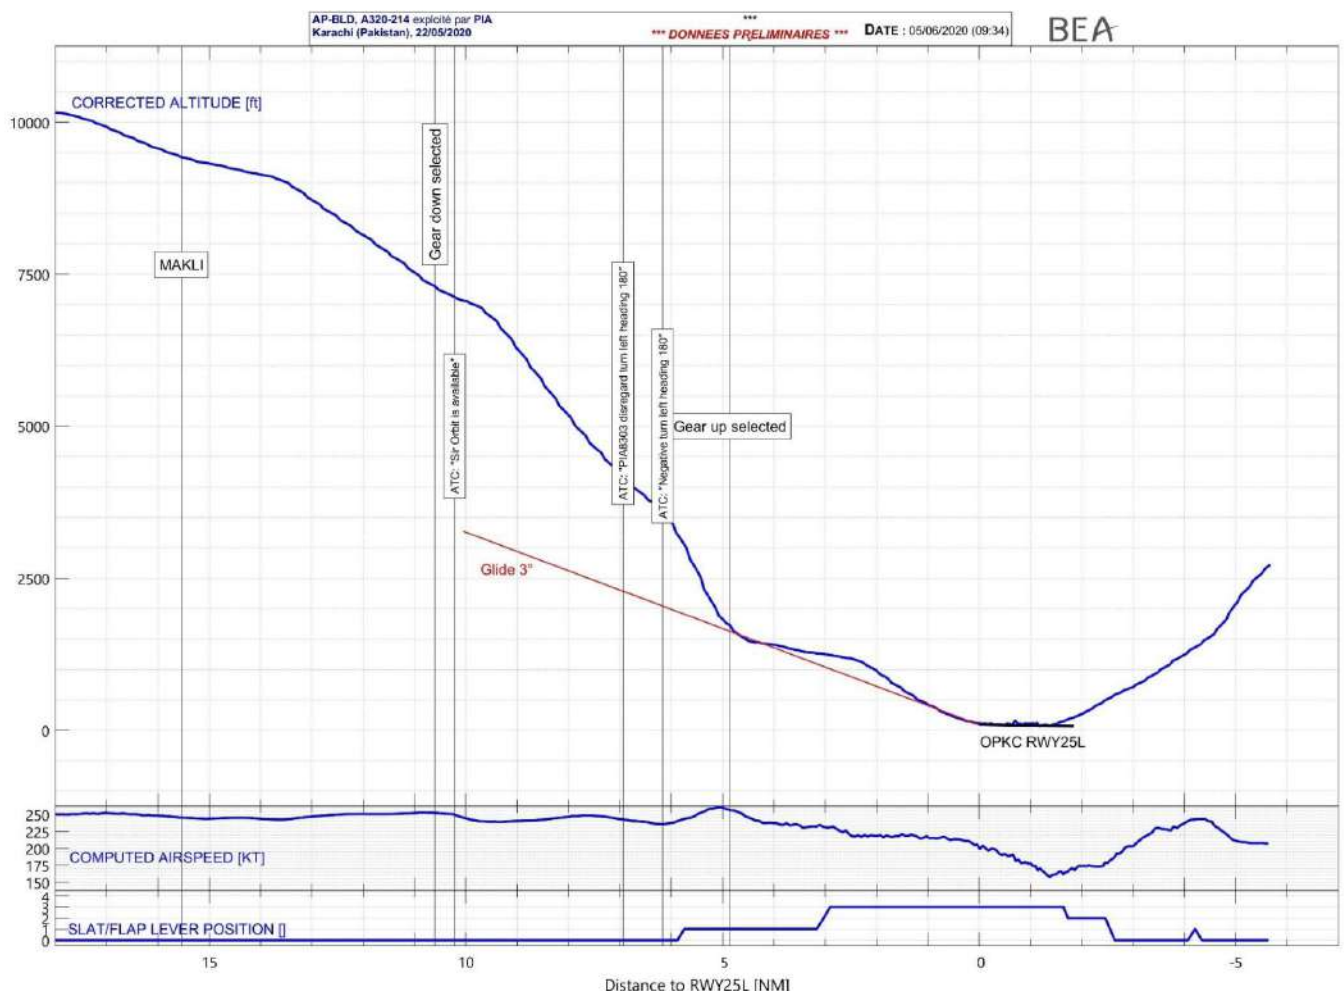
Fig 21 : Selected FDR parameters during last part of the first approach

(d) The aircraft ended up higher than the required descend profile. At MAKLI the aircraft was at 9780 ft and at about 245 knots IAS. In order to manage the descent and lose the additional height, “OPEN DES” mode was selected via the FCU, both autopilots were disengaged and speed brakes were extended.

(e) “Karachi Approach” inquired “confirm track mile comfortable for descend” and later advised to take an orbit, so that the aircraft can be adjusted on the required descend profile. No orbit was executed and the effort to intercept the glide slope and localizer (of ILS) was continued. The FDR indicated action of lowering of the landing gears at 7221 ft at around 10.5 Nautical Miles from Runway 25L.

(f) “Karachi Approach” advised repeatedly (twice to discontinue the approach and once cautioned) about excessive height. Landing approach was not discontinued. However, FDR shows action of raising of the landing gears at 1740 ft followed by retraction of the speed brakes (at a distance slightly less than 05 nautical miles from the runway 25L). At this time, the aircraft had intercepted the localizer as well as the glide slope. Flaps 1 were selected at 243 knots IAS, the landing gears and speed brakes were retracted. Over-speed and EGPWS warnings were then triggered.

(i) At 500 ft, the FDR indicates: landing gear retracted, slat/flap configuration 3, airspeed 220 knots IAS, descent rate 2000 ft/min. According to the FDR and CVR recordings several warnings and alerts such as over-speed, landing gear not down and ground proximity alerts were disregarded. The landing was undertaken with landing gears retracted. The aircraft touched the runway surface on its engines. Flight crew applied reverse engine power and initiated a braking action. Both engines scrubbed the runway at various locations causing damage to both of them. Figures hereunder show selected screenshots of security / CCTV cameras footages of the aircraft engines touching the runway and showing sparks due to scrubbing, along with marks on the runway.

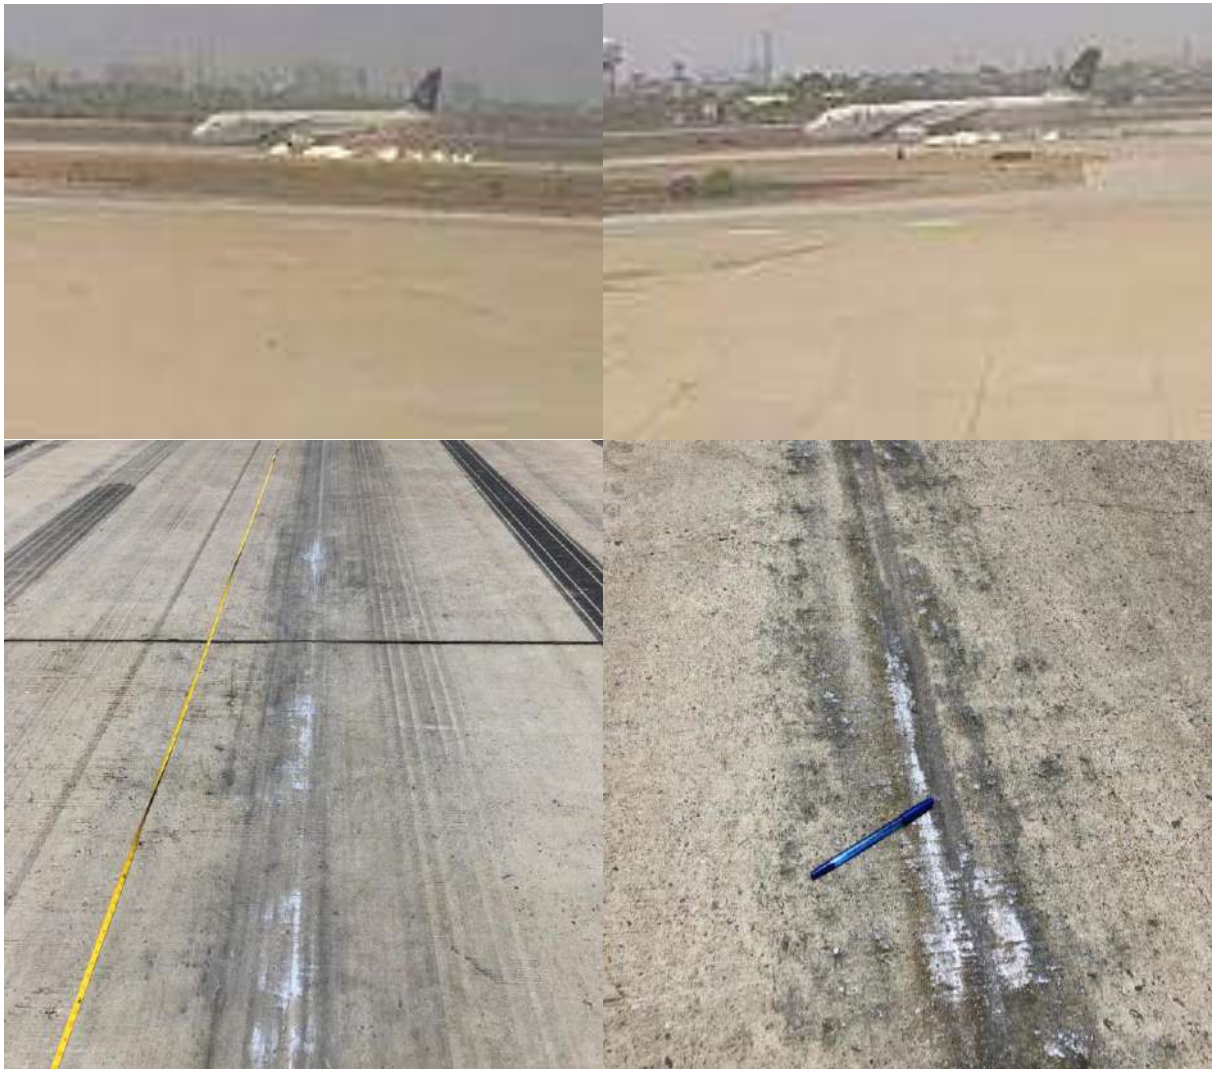
Fig 22 : Screenshots of security / CCTV cameras footages, and marks on runway

14. Transfer gearbox and drain mast reservoir, located at the engine lower part showed marks of friction with hard flat surface, material displacement and loss of material. It was consistent with the CCTV footages showing the lower part of the engine scrubbing the runway during the first landing attempt. The APU air intake flap actuator was not in the "retracted" position, consistent with the APU not being used at the time of impact, ie not

15. Some parts recovered from the runway 25L were identified as CFM56-5B engine and A320 nacelle parts, consistent with the CCTV videos of the airport showing the lower part of the nacelle and engines impacting the runway during the first landing attempt.
